## **Case Study of Micro-Contamination Control**

### **Abstract**

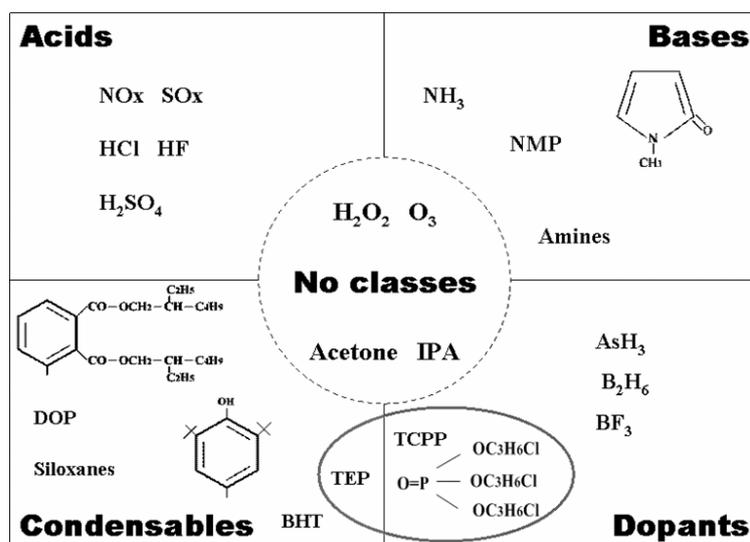
Fig. 1. Schematic of five AMC categories.

Airborne contaminants render various defects on an electronic device. For example, molecular acid (MA) causes corrosion problem (Higley and Joffe, 1996); molecular base (MB) induces T-topping damage (Ruede *et al.*, 2001); molecular condensable (MC) shifts the deposited film property from Si-N to Si-O (Saga and Hattori, 1997) and hazes the photo lens (Barzaghi *et al.*, 2001); molecular dopant (MD) swaps the p-type and n-type properties (Lebens *et al.*, 1996); ozone ( $O_3$ ) lowers the device capacitance (Park *et al.*, 2001). The contaminants in each of the five airborne molecular contamination (AMC) categories are shown in Fig. 1 (Ayre *et al.*, 2005). Besides, a particle larger than 1/3 of the feature size might fail a die (Kitajima and Shiramizu, 1997). To reduce the wafer losses resulting from airborne contamination, the yield enhancement committee of the International Technology Roadmap for Semiconductors (ITRS) annually publishes a guideline to detail the tolerable concentrations for various airborne contaminants in each technology node (ITRS, 2006). For the forthcoming 45 nm process, for instance, ITRS recommends that ammonia concentration be less than 2.5 ppb and critical particle size be 23 nm.

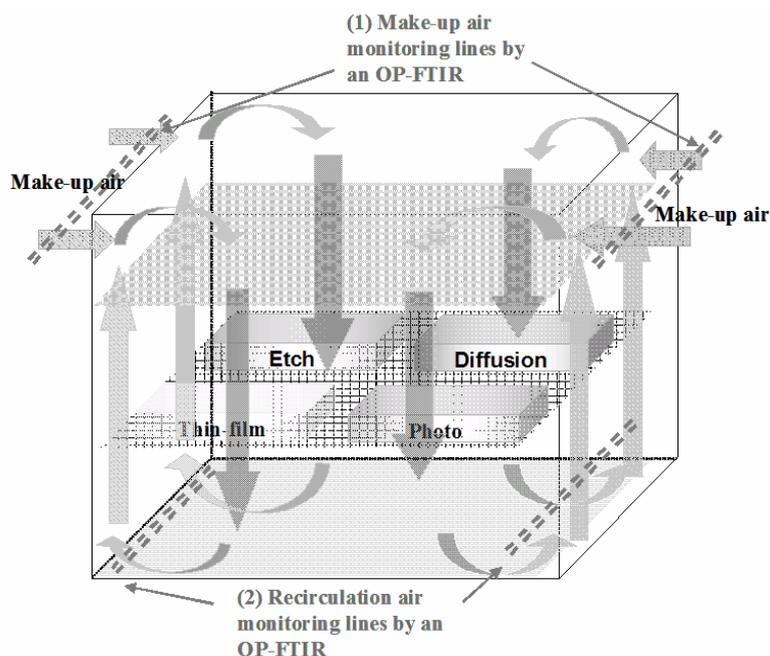
In theory, the best strategy to control the contaminants is to locate the emitting origin and to terminate the releasing source. As shown in Fig. 2, in a cleanroom, the contaminants mainly originate from two sources: (a) incoming outdoor air, and (b) internal activities. For the incoming outdoor air, as long as the contaminants are identified, a combination of particle and chemical filter can effectively remove the pollutants at the make-up air unit (MAU) (Kanzawa and Kitano, 1995; Muller, 2004; Yeh *et al.*, 2004).

**Fig. 2.** Schematic of air flow circulation and OP-FTIRs monitoring lines in a cleanroom.

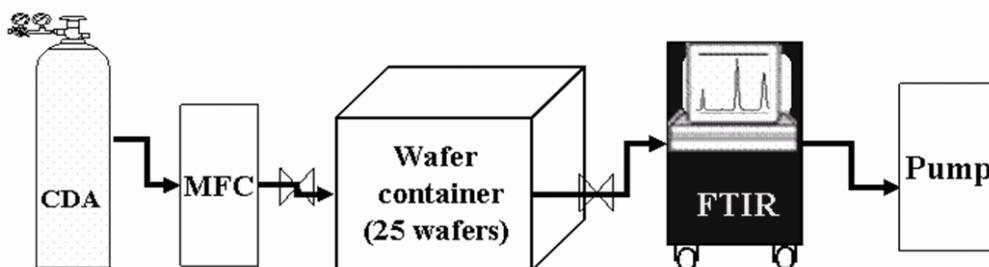
To determine the gas compositions and concentrations outgassing from the newly dry-etched wafers, as shown in Fig. 3, a compressed dry air (CDA) flow of 3 L/min, regulated by a mass flow controller (MFC), was used to continuously purge a batch of wafers (no. = 25). The purging N<sub>2</sub> flow was then directed to the 10 m gas cell (EA-2 L/10 m, Gemini Scientific Instruments,

Calif., U.S.A.) of a movable extractive fourier transform infrared (FTIR) spectrometer (Work IR-104, ABB Bomem, Quebec, Canada). The contaminants in the purging N<sub>2</sub> were instantly identified and quantified by the FTIR because of the fingerprint nature of the IR absorbance spectra for each gas and the advances of computer calculation capability.

**Fig. 3.** Experimental set-up for wafer outgassing tests.

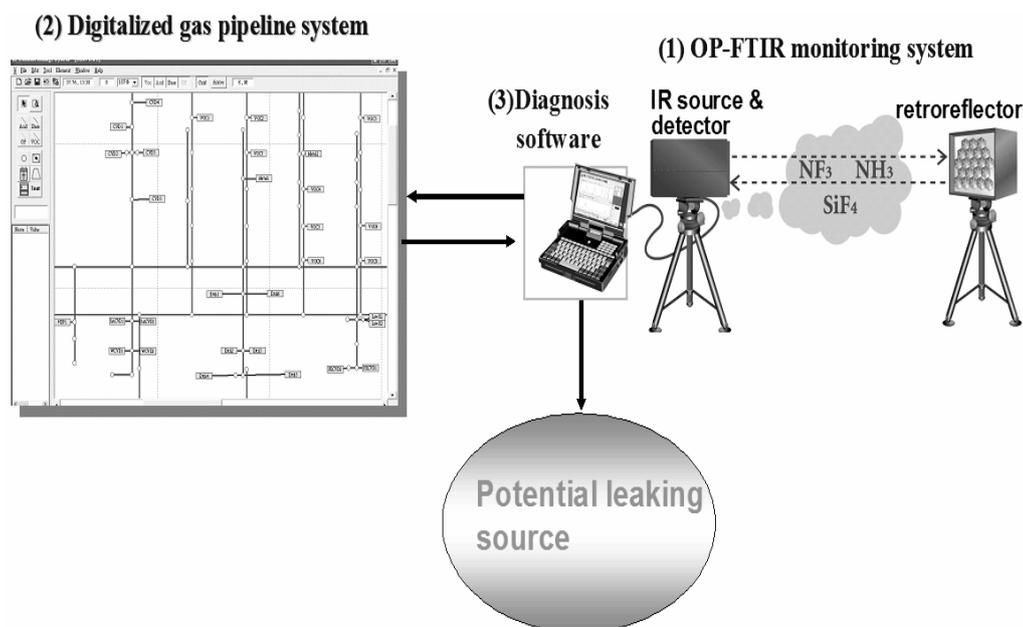
**Fig. 4.** Major components of the gas-leaking detection system (GLDS).

For the leaking spot locating, the gas-leaking-detection-system (GLDS) (Li et al., 2007) shown in Fig. 4 was applied to pinpoint the emitting source among thousands of gas pipelines. The GLDS is composed of two open-path Fourier transform infrared (OP-FTIR) spectrometers, a gas composition database and a diagnosis software to help determine the emitting origin. As Fig. 2 shows, one OP-FTIR is installed at the make-up air unit (MAU) to continuously monitor the incoming pollutants; the other OP-FTIR is situated at the recirculation air unit (RAU) to sense airborne contaminants inside the cleanroom. Upon detection of the contaminants at the RAU, as shown in Fig. 4, the diagnosis software will compare the gas compositions measured by two

OP-FTIRs to determine if the pollutant originates inside the cleanroom. If yes, the software automatically searches through the database to match the most probable leaking source and then sends a warning signal to the emergency response center (ERC) or to a responsible engineer for a follow-up mitigation action.

Although no odor complaint nor gas-sensor alarming was issued, the GLDS shown in Fig. 4 continuously sent a gas leaking warning to the responsible engineer. As Fig. 7 shows, there is an SF<sub>6</sub> emission source inside the fab because the measured SF<sub>6</sub> concentrations at the RAU (inside the fab) are significantly higher than those at the MAU (outside the fab). With the assistance of the computer software and the database, the suspected leaking source was identified as the exhaust pipelines of poly-etchers. By comparing the measured on-off times of SF<sub>6</sub> (by OP-FTIR) with the operation records of poly-etchers and by applying a mobile extractive FTIR along the exhaust pipelines, the leaking spot was then determined to be a cracking duct behind a poly-etcher pump. By applying the GLDS, the gas leaking can be sensed in a very early stage and the losses caused by the gas leakage can also be greatly reduced.

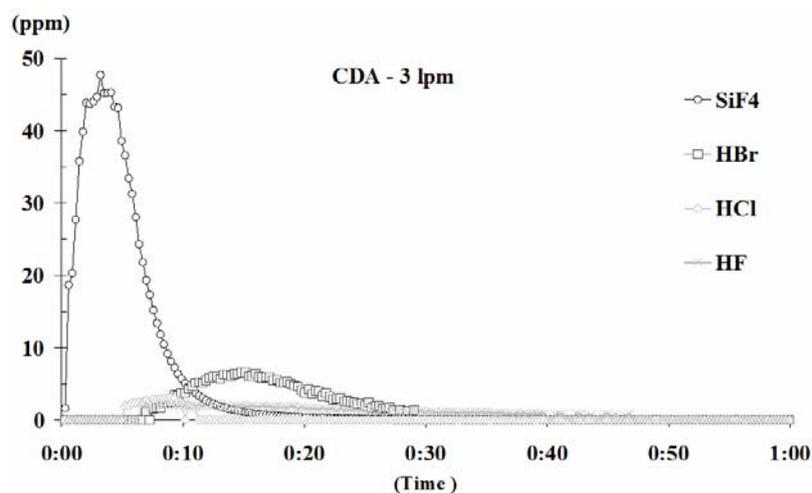
Fig. 5 shows the releasing gas concentration profiles from a batch of newly dry-etched wafers. High concentrations of acid gases ( $\text{SiF}_4$ , HBr, HCl, HF) continuously release from wafers for more than 30 minutes. Without appropriate control measures, the MAs would emit into the cleanroom to contaminate near-by wafers and to cause corrosion on equipment surfaces. In four MAs,  $\text{SiF}_4$ , a dry-etching product ( $\text{Si} + \text{F} \rightarrow \text{SiF}_4$ ), constitutes the major emissions with a peak concentration of 48 part-per-million (ppm); HBr and HCl are residual process gases and HF is the by-product of  $\text{SiF}_4$  hydrolysis.

**Fig. 5.** Concentration variations of acid gases outgassing from newly dry-etched wafers (no. = 25).

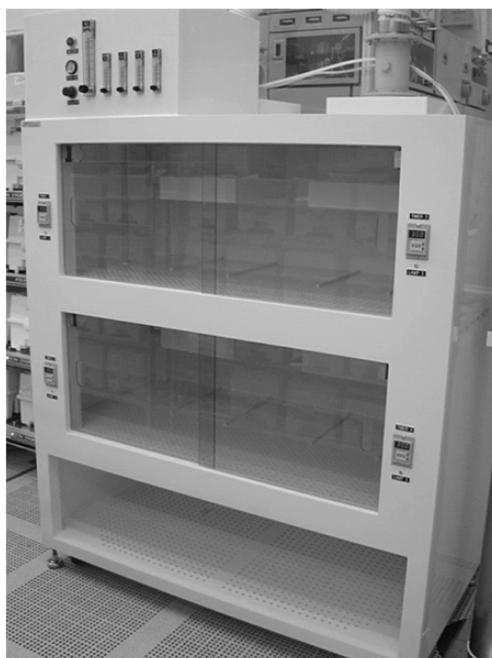
To prevent the MAs from spreading around the cleanroom, a well-vented storage cabinet shown in Fig. 6 was constructed. The dimensions of the storage cabinet are 1.4 m by 1.5 m by 0.75 m and the internal circulation air flow rate equal to 4200 L/min. Based on the findings of this study, the newly dry-etched wafers were temporarily arranged inside the cabinet for 20-60 minutes to diffuse out the MAs before being sent to the next process equipment. With this arrangement, the effect of throughput losses can be minimized.

**Fig. 6.** Photo of a wafer storage cabinet for capturing the outgassing acid gases.(Dimensions: 1.4 m by 1.5 m by 0.75 m, circulation air flow rate = 4200 L/min).

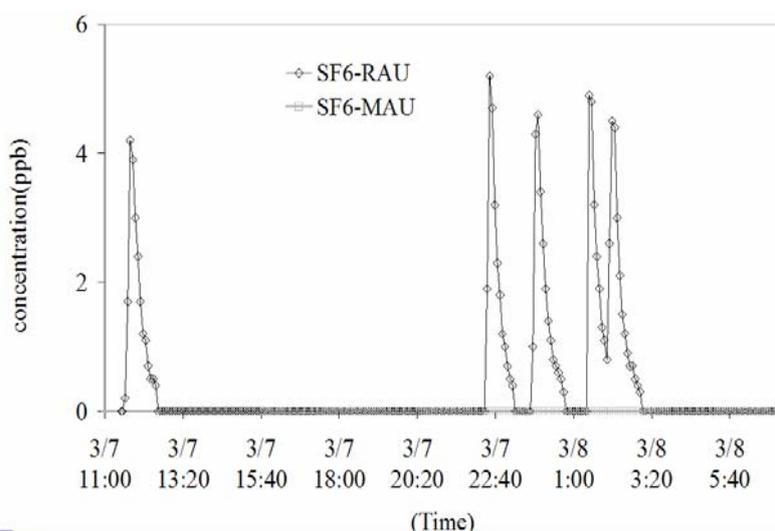
**Fig. 7.** Measured SF<sub>6</sub> concentrations at the RAU (diamond symbols) and at the MAU (square symbols) by two OP-FTIRs.

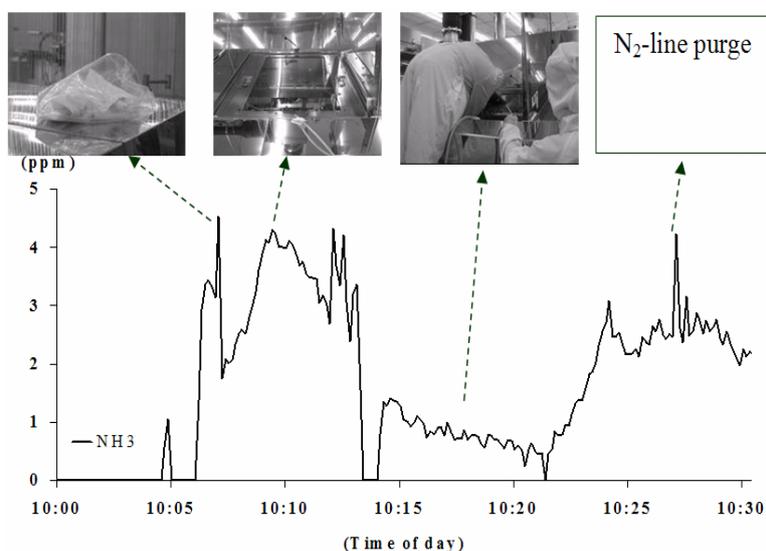
suspected photo-resist stripper during its preventive maintenance (PM) activity. As Fig. 8 shows, high concentration of  $\text{NH}_3$  was continuously emitted into the cleanroom during the PM of the photo-resist stripper, which used mono-ethanol-amine (MEA) as its stripping chemical. The three photos shown on the top of Fig. 8 represent  $\text{NH}_3$  emissions from used wiping cloth (left one), from the gap around the chamber door rim (middle one) and from the activities of cleaning the chamber inner surfaces (right one). To control the  $\text{NH}_3$  emission, air-tight chamber lids were applied around the rims of the process tool and distilled-water flush steps were added to reduce residual chemicals condensed on the internal walls. For the potential  $\text{HNO}_3$  (or similar chemical) source, unfortunately, it was not found.

**Fig. 8.** Fugitive  $\text{NH}_3$  emissions in the PM activity of an LCD stripper which uses mono-ethanol-amine (MEA) as its stripping chemical.

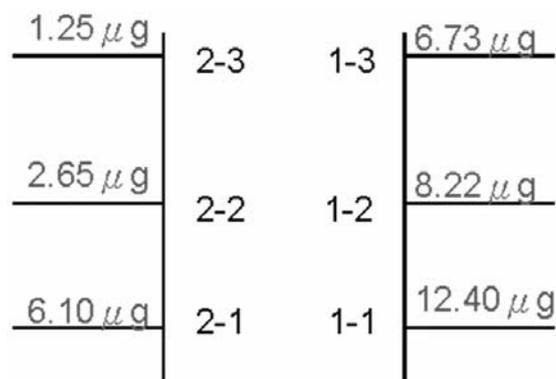
Fig. 9 shows the measured boron quantity on each frame surface of an LCD stocker by randomly wiping an area of 0.1 m-by-0.1 m with KOH-impregnated filters. The results clearly demonstrate that the stainless-steel frames, which are used to support the LCD glass substrates in a stocker, are a boron emission source. When the glass substrates were stored inside the stocker to wait for the next process equipment, they were contaminated by the boron emitting from the surfaces of the stainless-steel frames. The boron on the frames could originally come from the fugitive emissions of the glass substrates. With long-time (~1 year) accumulation, the boron quantity on the frames became significant and detrimental although the boron emission from each glass substrate was insignificant. To resolve the boron contamination problem inside the LCD stocker, it was recommended that the stainless-steel frames be cleaned periodically (~once per month) with KOH-DDW solution to avoid significant boron accumulation.

**Fig. 9.** Accumulated boron quantity on each support frame of an LCD stocker.
